RAILWAY INVESTIGATION REPORT

R03Q0022

MAIN-TRACK DERAILMENT

CANADIAN NATIONAL

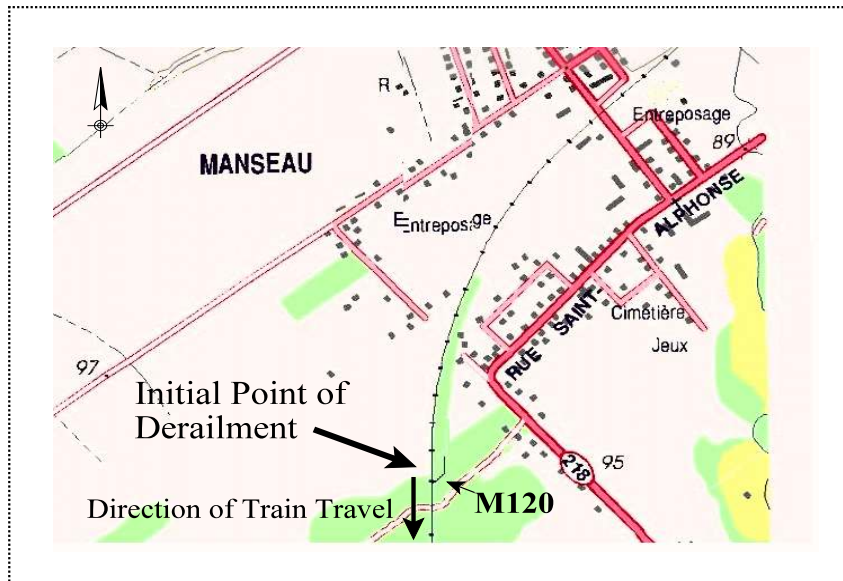
In the area of the accident (see Figure 2), the track had a slight ascending grade of 0.3 per cent, followed by a slight descending grade of minus 0.3 per cent. The M120 spur switch is at the exit spiral of a two-degree, one-minute left-hand curve (in the direction of train travel) at Mile 53.09. The first marks on the track were located 39 feet east of the switch frog.

Figure 2. Schematic showing initial point of derailment at the end of the exit spiral at Mile 53.09 of the Drummondville Subdivision (Source: Quebec's Ministry of Natural Resources).

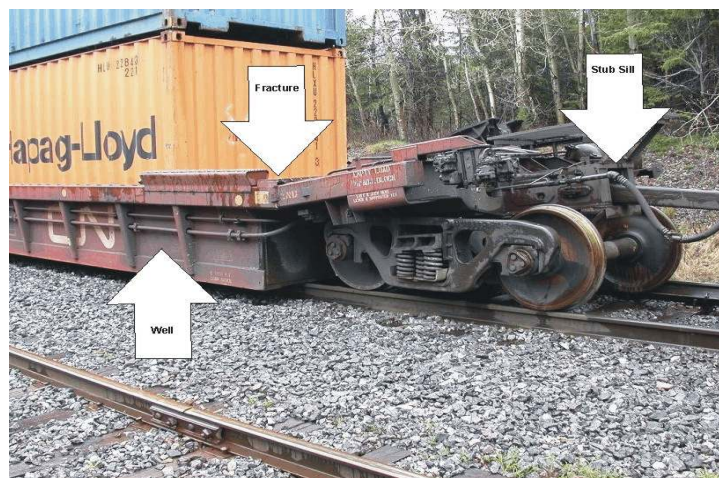
Overview. Photo 1 shows the fractured car on the track, and Photo 2 shows the same car after the wheel sets had been removed. The cargo area of this car is box-shaped, and referred to as the “well.” These photos show fractured side sills, and the fracture along the forward lower edge of the well, where the lower edge of the stub sill attaches.

Photo 1. Position of car CN 677048 after the derailment

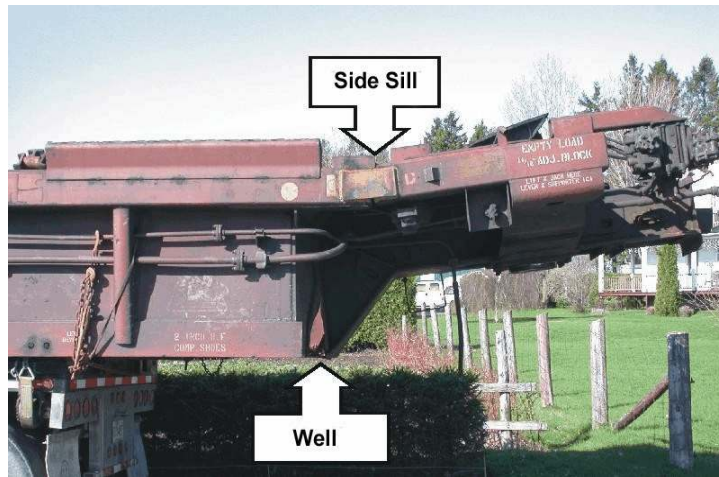
Photo 2. Side view of the platform loaded on a highway trailer for transport. Arrows show location of failure.

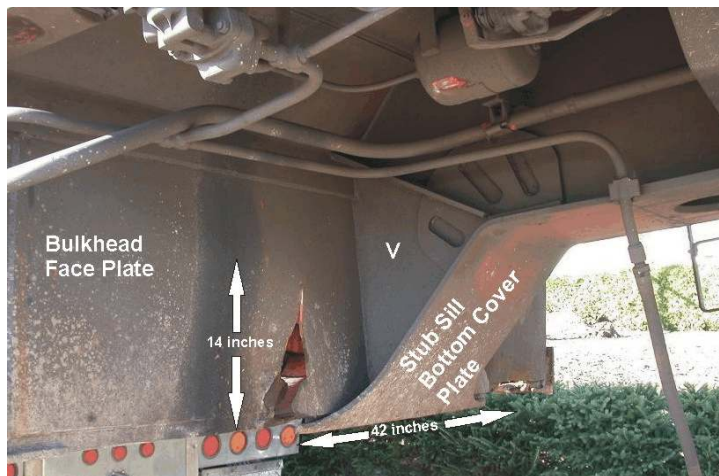
Well Fracture. Photos 3 and 4 show the fracture along the lower front edge of the well, where the lower edge of the stub sill tore away from the bulkhead face plate. The lower front edge of the bulkhead face plate was attached to a steel angle. The fracture occurred through the steel angle, at the toe of the weld that attached the steel angle to the floor, and was approximately 42 inches in length. The vertical fracture surfaces were of different lengths. For the side of the car that was on the high side of the curve, the fracture measured approximately 14 inches, and for the low side, it measured 12 ½ inches. There were red paint flecks noted within the weld area at the fracture surface. There were also signs of rust, fretting, and contamination similar to that produced by wayside lubricators on the fracture surfaces. It was also noted that there were two vertical welds (item W, Photo 4) in the bulkhead face plate behind the stub sill attachment area. Other than ballast that entered the well area during the derailment sequence, there was only a minor amount of debris noted (e.g. a worn brake shoe and rubber air brake gaskets).

Photo 3. Lower front edge of bulkhead face plate as viewed from the underside of the car in the stub sill area

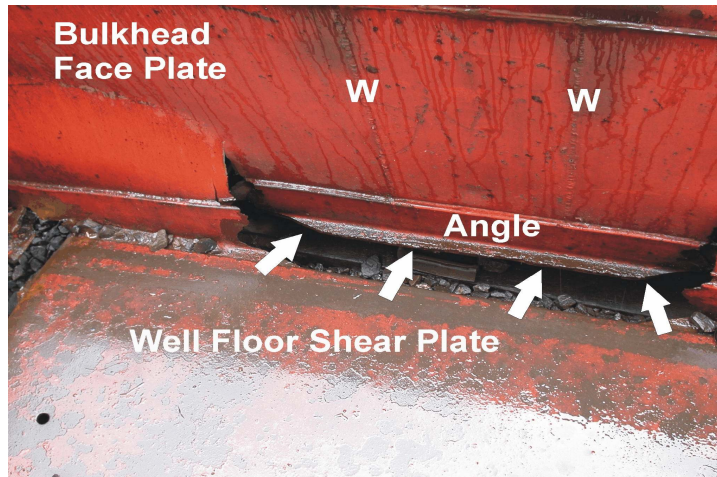
Photo 4. View of the fracture from inside of well. Arrows denote the location of the fracture on the steel angle.

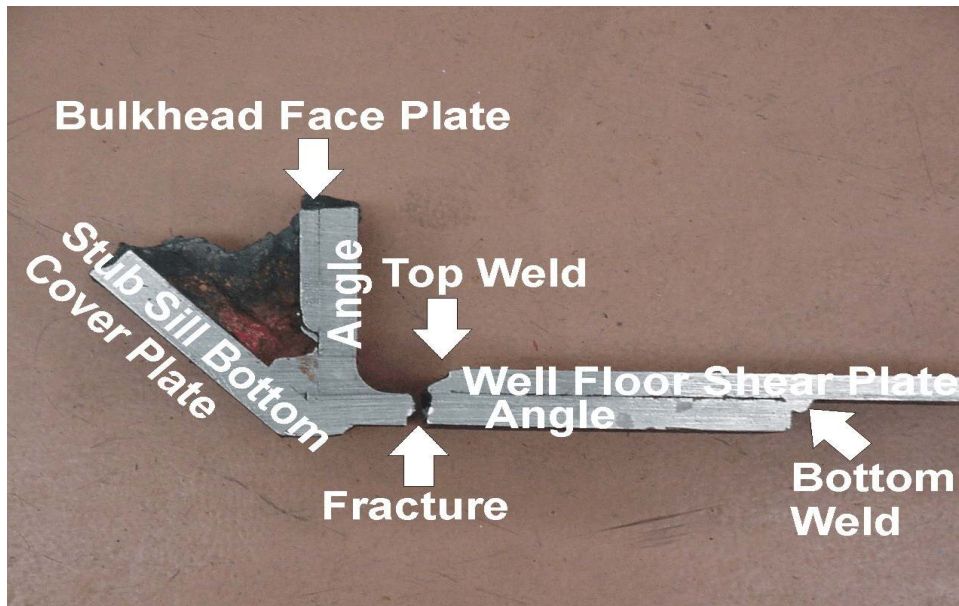
Photo 5 shows a cross-sectional view of the geometry of the parts involved in the area where the bottom steel angle attaches to the stub sill and floor. The specimen was taken from the opposite undamaged end of car CN 677048-E after a pre-existing crack was mechanically opened.

Photo 5. Typical geometry of steel angle area at the bottom of the well

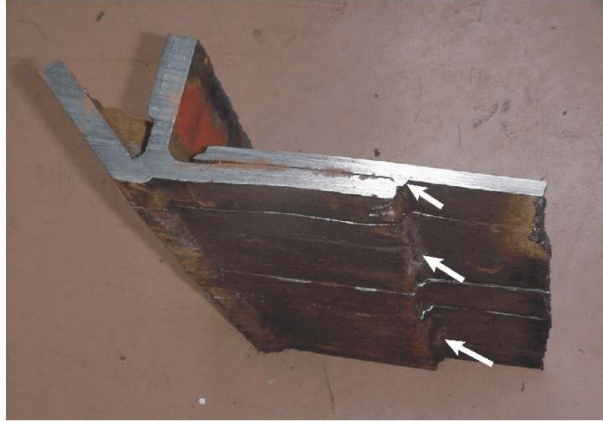
Pre-existing cracking was noted in similar locations at both ends of the platform, and a fillet weld in a critical area was missing on the end that collapsed (see Photos 6 and 7).

Photo 6. Undamaged end of platform showing weld that connects the underside of the well floor shear plate to the steel angle

- A pre-existing crack was present at the opposite undamaged end of the same car, along the lower edge of the well, having the same appearance and location as the principal fracture.

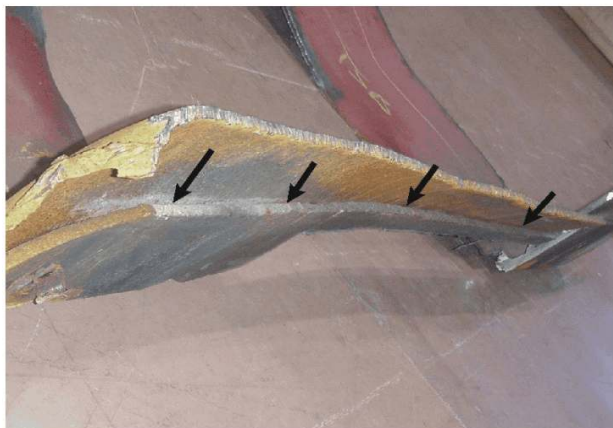
Photo 7. Underside of the well floor shear plate and steel angle showing the missing weld on the end that collapsed

- The weld that normally connects the steel angle to the underside of the well floor was missing at the failed end. This would have resulted in higher-than-normal loads at the failure location, and would have accelerated the fatigue process. The extent of this acceleration could not be quantified.

Because there was a missing weld under the car where the well attached to the steel angle, loads were transferred through this highly stressed region through just one weld instead of through two. Therefore, the region around that single weld was subjected to higher stresses than the opposite end of the car. This accelerated the growth of the fatigue cracks on the end that collapsed to the point where the car body could not support normal loads. As the five-pak was

On 14 May 2003, Canadian National (CN) issued instructions to all its field inspection forces to visually inspect all cars in the CN 677 series (Appendix B). All welds and the area around where the stub sill and the lower shear plate attached to the end sill of the car were inspected for cracks or any sign of failure both inside and outside the container well. The welds were cleaned with a wire brush to provide a good visual inspection. As this inspection was considered critical,
